# Nelson North Wastewater Treatment Plant

## Natural Hazards Assessment

**Prepared for**  
Nelson City Council  
**Prepared by**  
Tonkin & Taylor Ltd

**Date**  
June 2023  
**Job Number**  
1006675.0900 v2

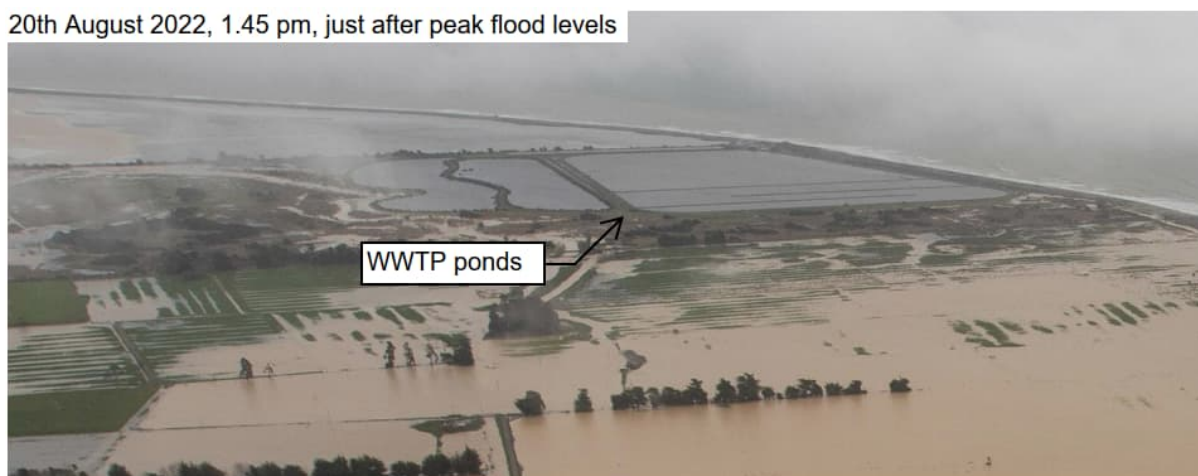
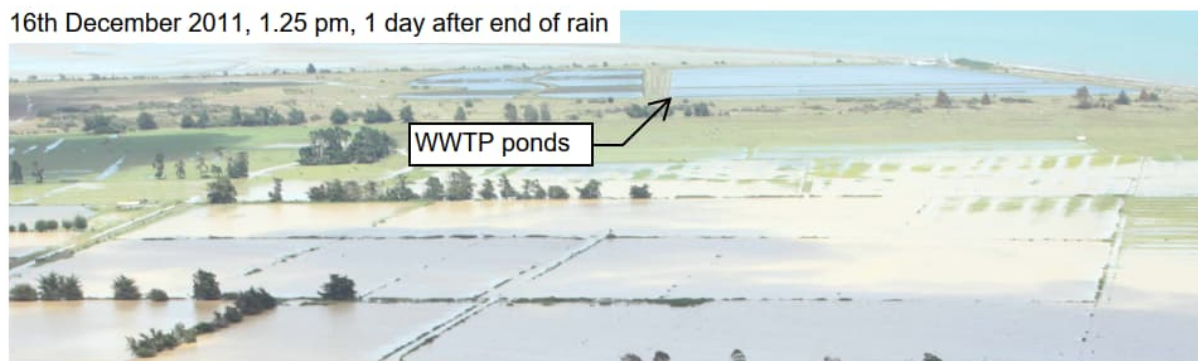
We have reviewed evidence of the extent of the August 2022 flooding on the Wakapuaka flood plain, and compared this to the Present Day flood modelling results. Based on this, we have assessed that the August 2022 rainfall resulted in flooding between the calculated 1% (1 in 100 year) and 2% (1 in 50 year) AEP flood extents. The only effect on the WWTP that we are aware of at this time is that the daily wastewater inflow peaked on the 19<sup>th</sup> August at 55,270 m<sup>3</sup>/d, 5-6 x the normal August daily inflow, and was diluted due to large amounts of stormwater entering the wastewater network. Historical photos of the Wakapuaka flood plain during the 2022 and 2011 floods are included below.

Figure 4.1: Historical photographs of the Wakapuaka flood plain, showing the WWTP typically being above the flood waters

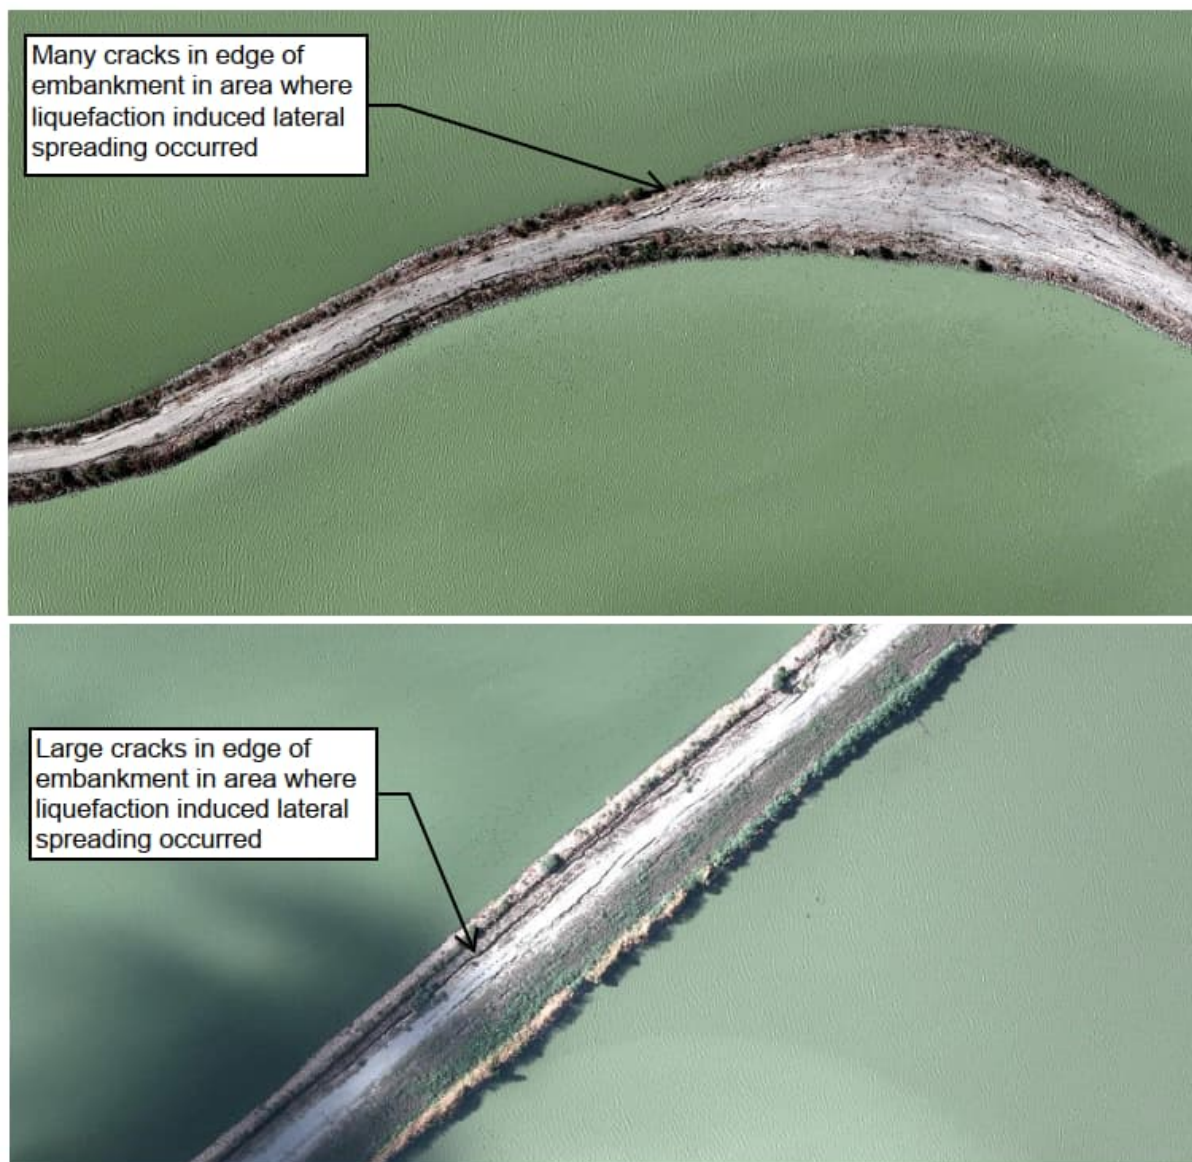
In the February 2011 earthquake, the strength of the ground shaking recorded near the Christchurch WWTP, at the Pages Road Pumpstation, was close to the 1 in 500 year event shaking shown in Figure 5.2 for the Nelson North WWTP. Given the similarities between the two sites, this is a relevant example for the type and magnitude of damage that may occur during a similar size earthquake.

Figure 5.4: aerial photographs shown liquefaction induced lateral spreading damage in embankments at the Christchurch WWTP following the February 2011 earthquake<sup>vii</sup>
