IN THE MATTER of **Private Plan Change 28** to the Nelson Resource Management Plan

JOINT WITNESS STATEMENT (JWS) IN RELATION TO:

Maitahi Valley Farm Buildings, 7 Ralphine Way, Maitai Valley Nelson

Addendum Report

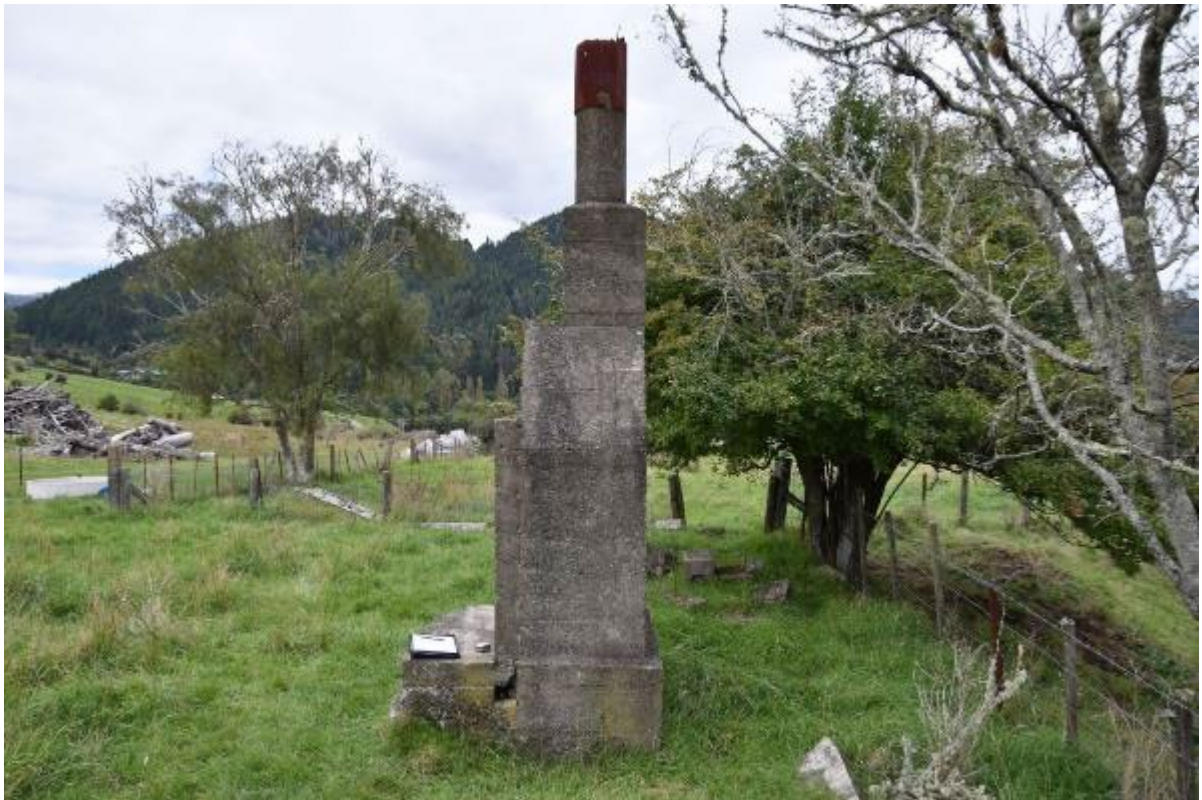
The chimney (1) comprises a concrete base measuring approximately 1250 x 1300mm and 600mm high. On top of this is a concrete fireplace and flue measuring approximately 600 by 1170mm with a cast-in nib, which forms the opening to the fireplace and mantle (measuring approximately 1200 by 1220 by 130mm). Above the fireplace, the chimney tapers into a rectangular flue approximately 600mm high on top of which is a c.900mm circular flue of approximately 250 / 300mm in diameter. This has a rusty steel sheet cladding to the top.

Photo 1 The concrete chimney and hearth.

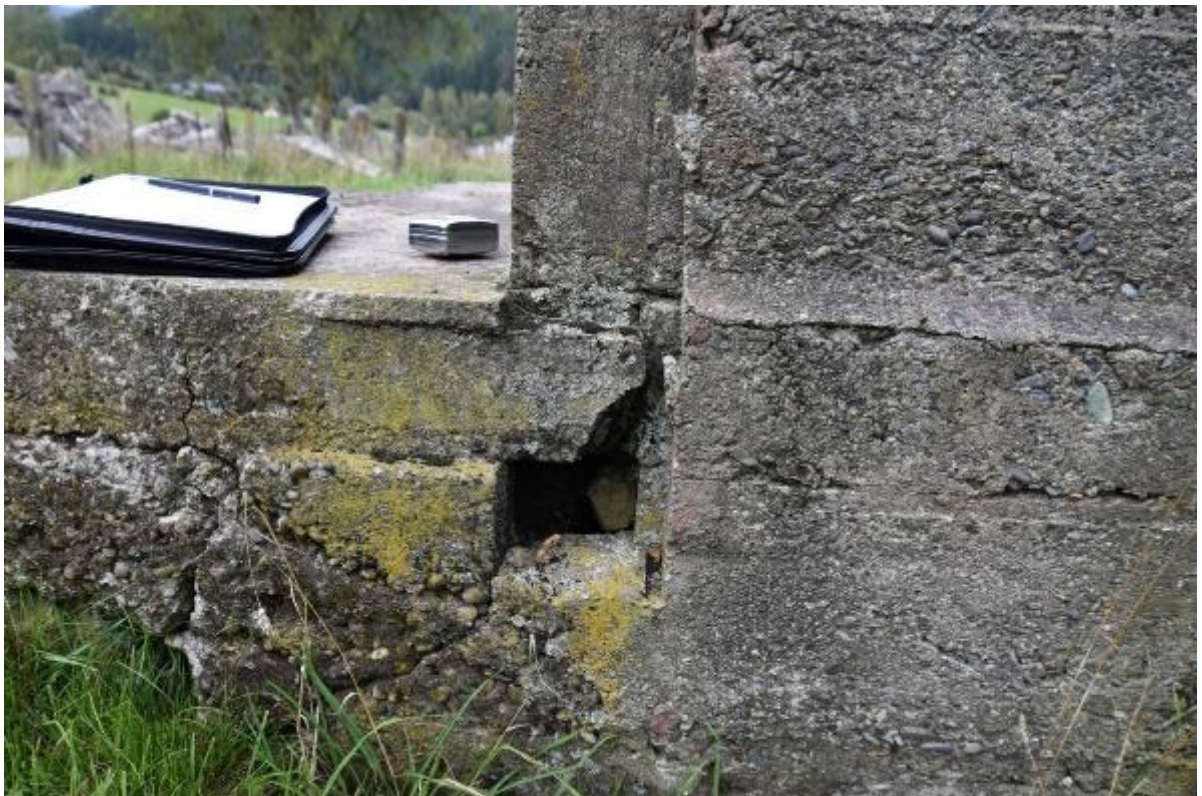
The profile of the concrete shuttering can be seen in the chimney, together with (on the inside face of it) the profile of rusticated weatherboards, which were the external cladding for the building when the chimney was cast onto it (2-4). The lines of the rusticated weatherboards can be seen as regular horizontal, slightly curved projections, in the concrete above the fireplace opening and down each side of it.

Photo 2 Bottom plate pocket for a framed wall with the rusticated weatherboard line adjacent on the right.

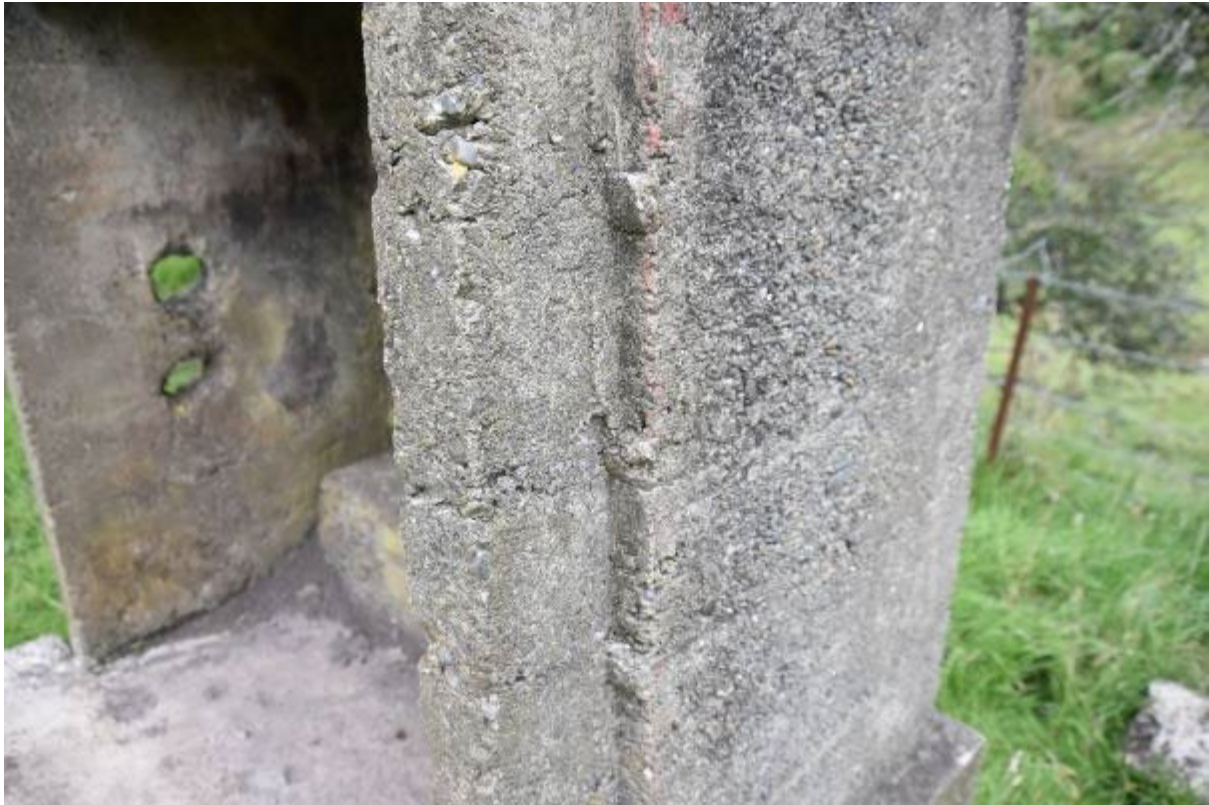
Photo 3 Rusticated weatherboard imprints where the concrete was cast against them.

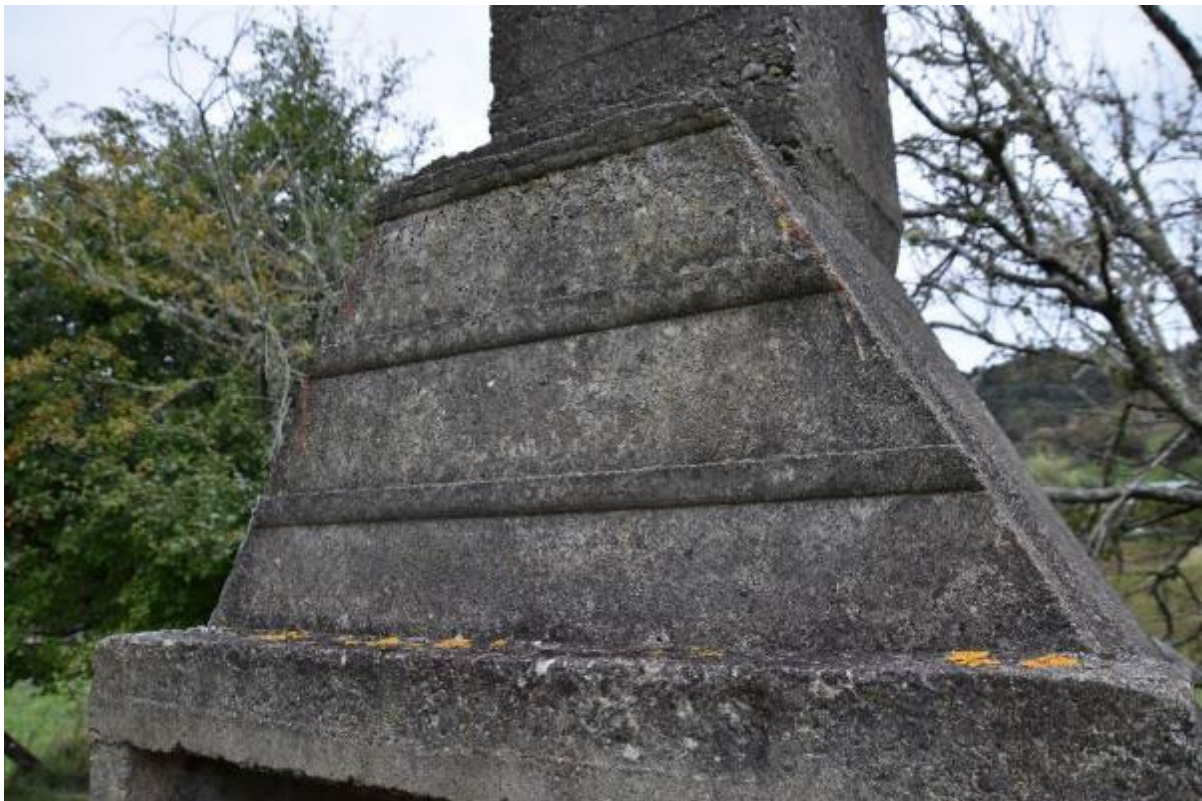
Photo 4 Rusticated weatherboard imprints in the concrete above mantel level.

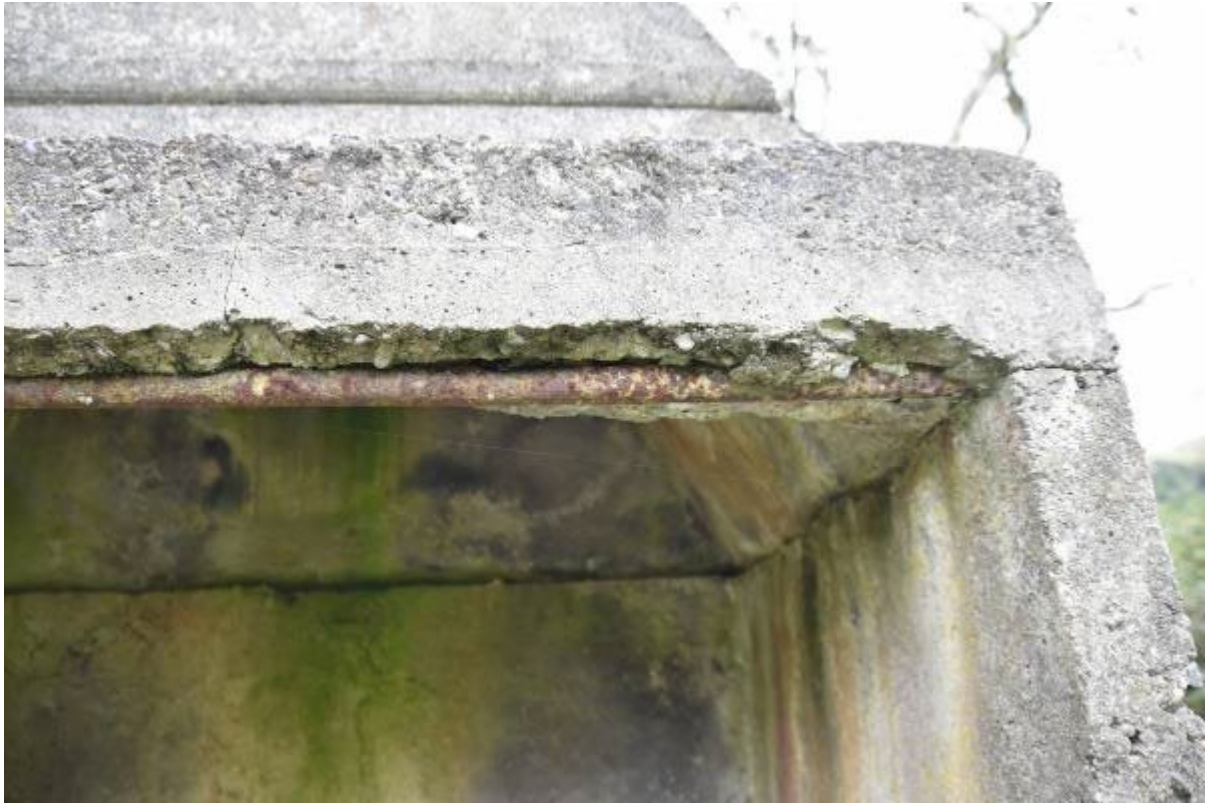
Photo 5 Hollow steel rod cast into the concrete to act as a lintel over the fireplace opening.

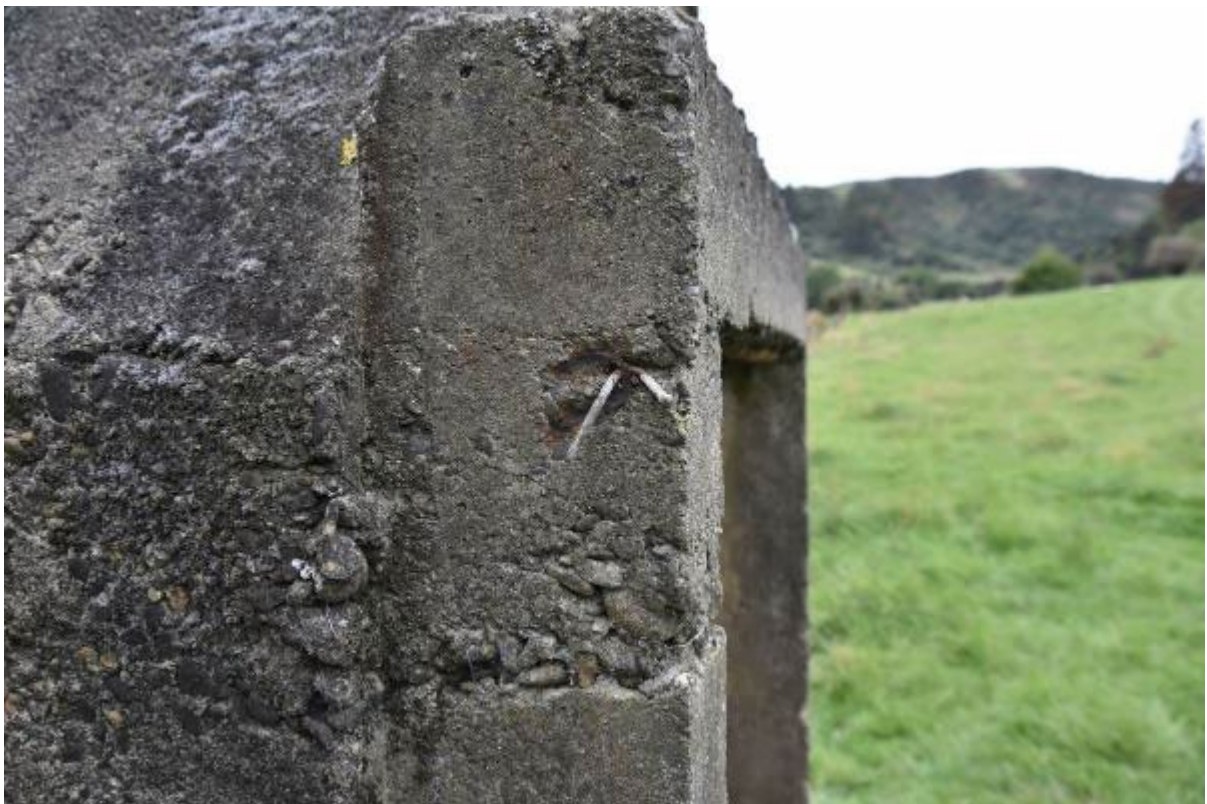
Photo 6 Galvanised steel wire nail attached to the steel rod lintel (likely post 1945).

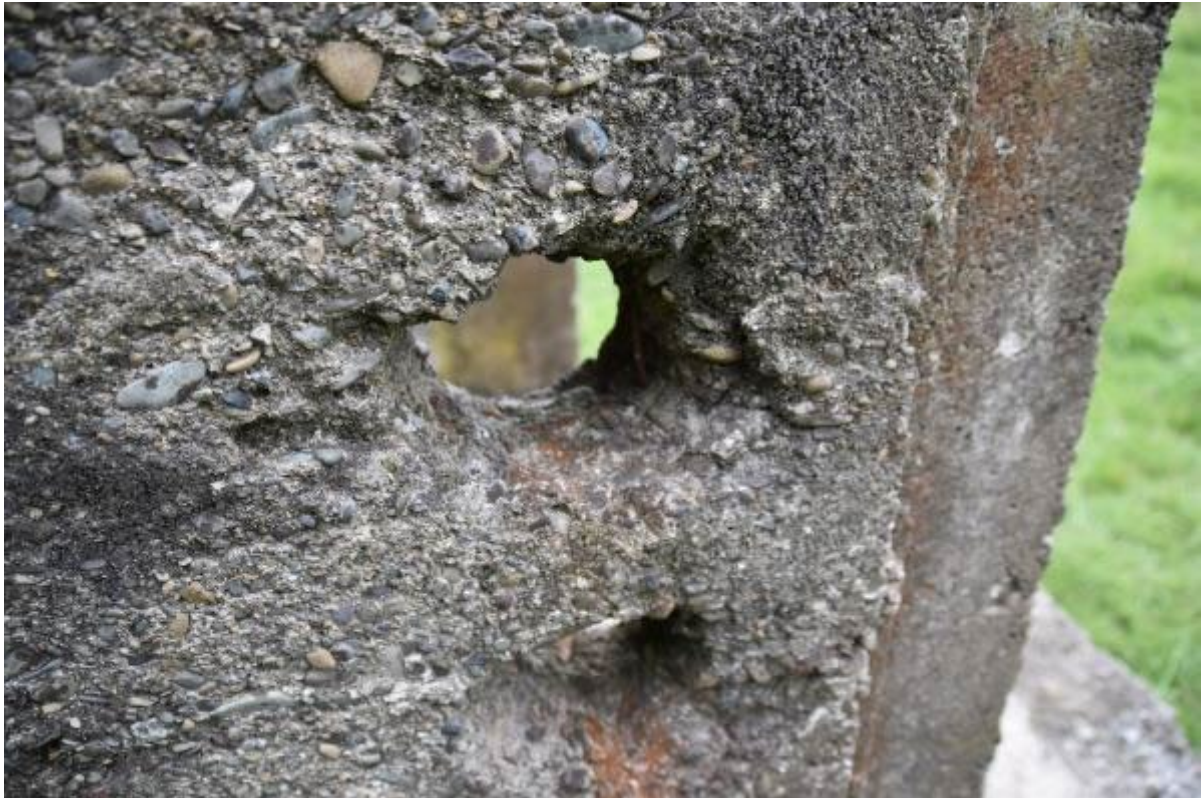
Photo 7 Holes in the side of the fireplace likely to be for pipework (wetback, etc). Wire reinforcing exposed in the holes.

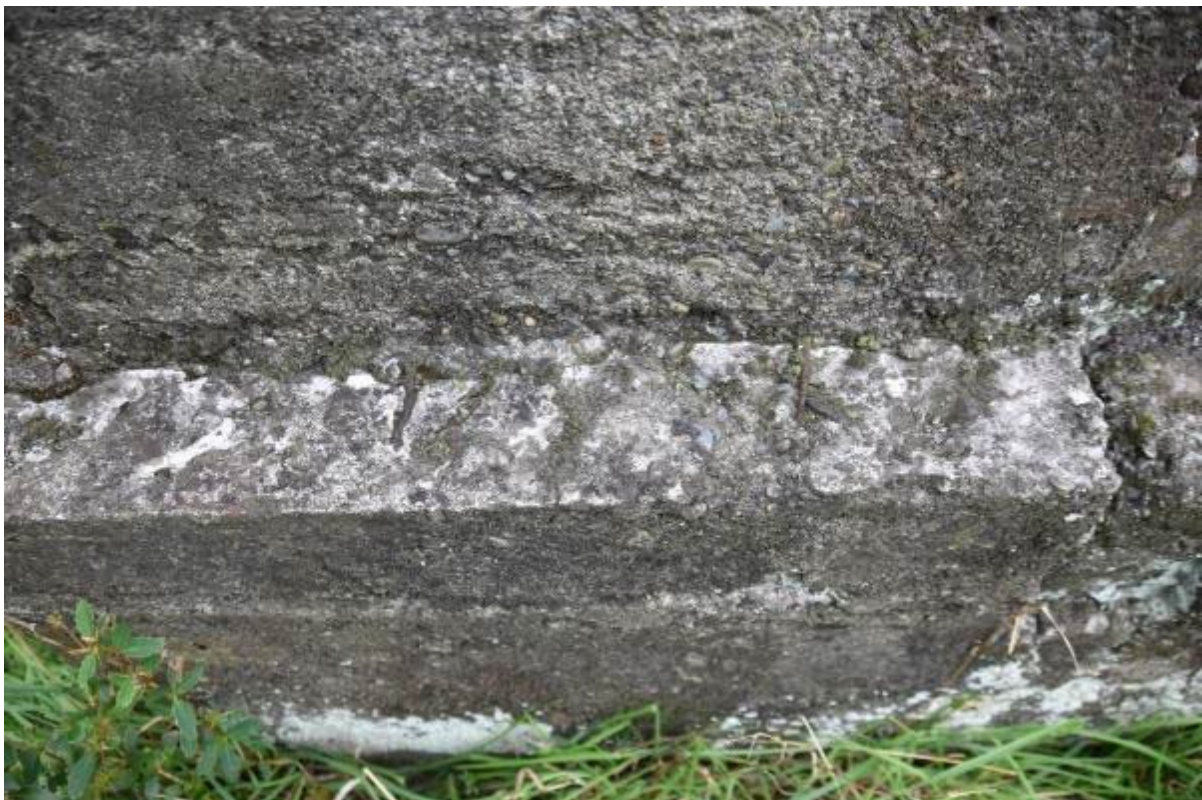
Photo 8 Wire reinforcing in the concrete foundation/base of the chimney.

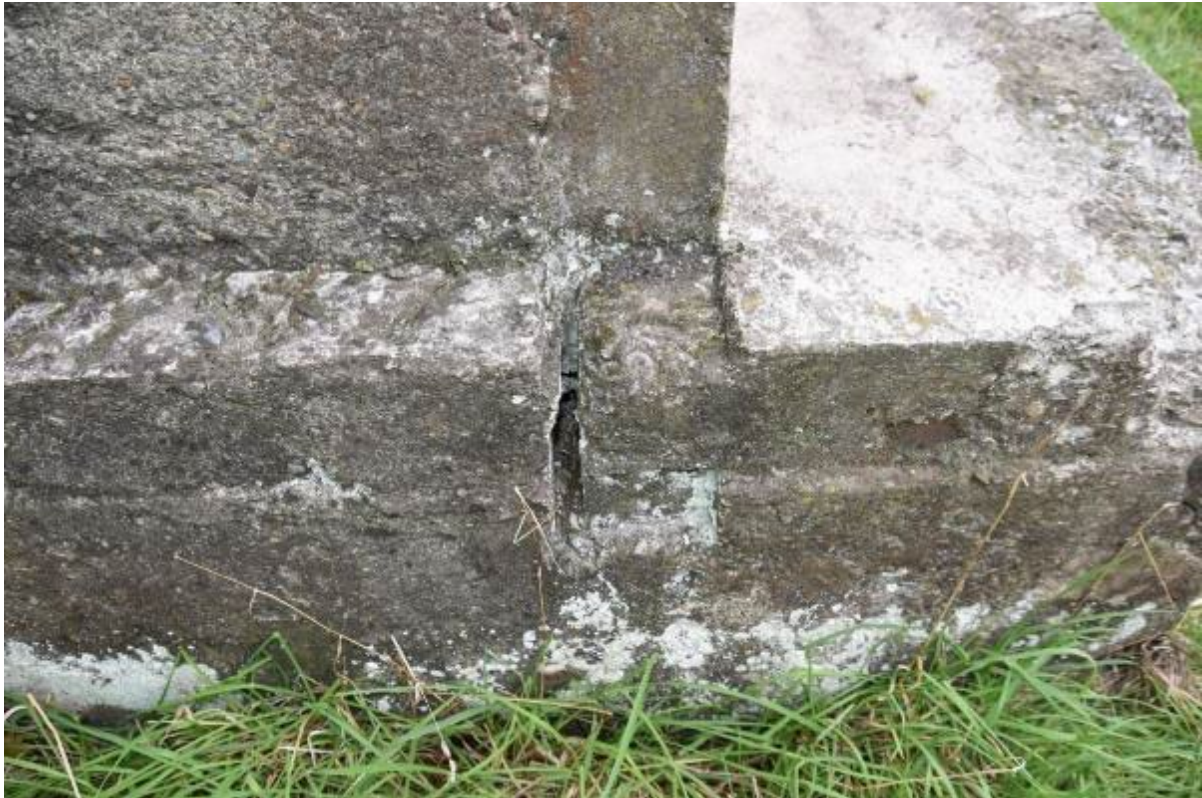
Photo 9 Bottom plate and weatherboard imprint in the concrete on the other side of the chimney to that shown in photo 2.

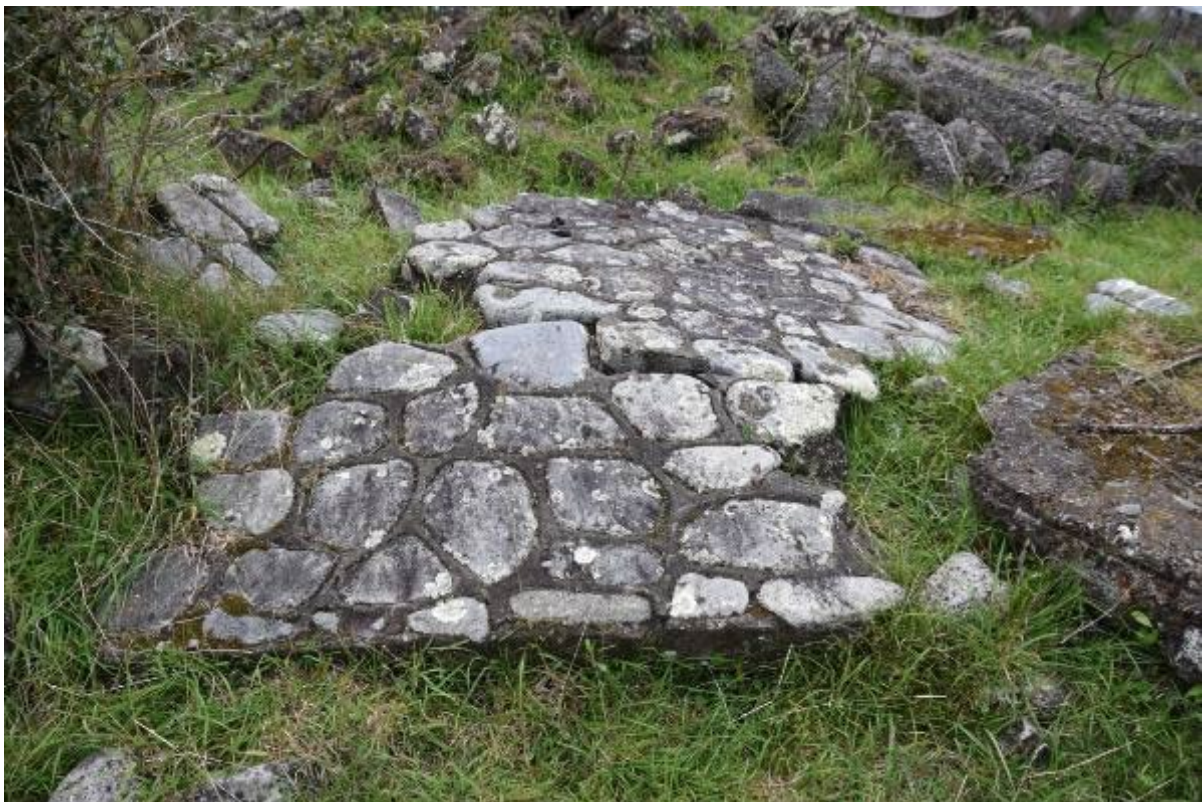
Photo 10 Some of the concrete and stone rubble.

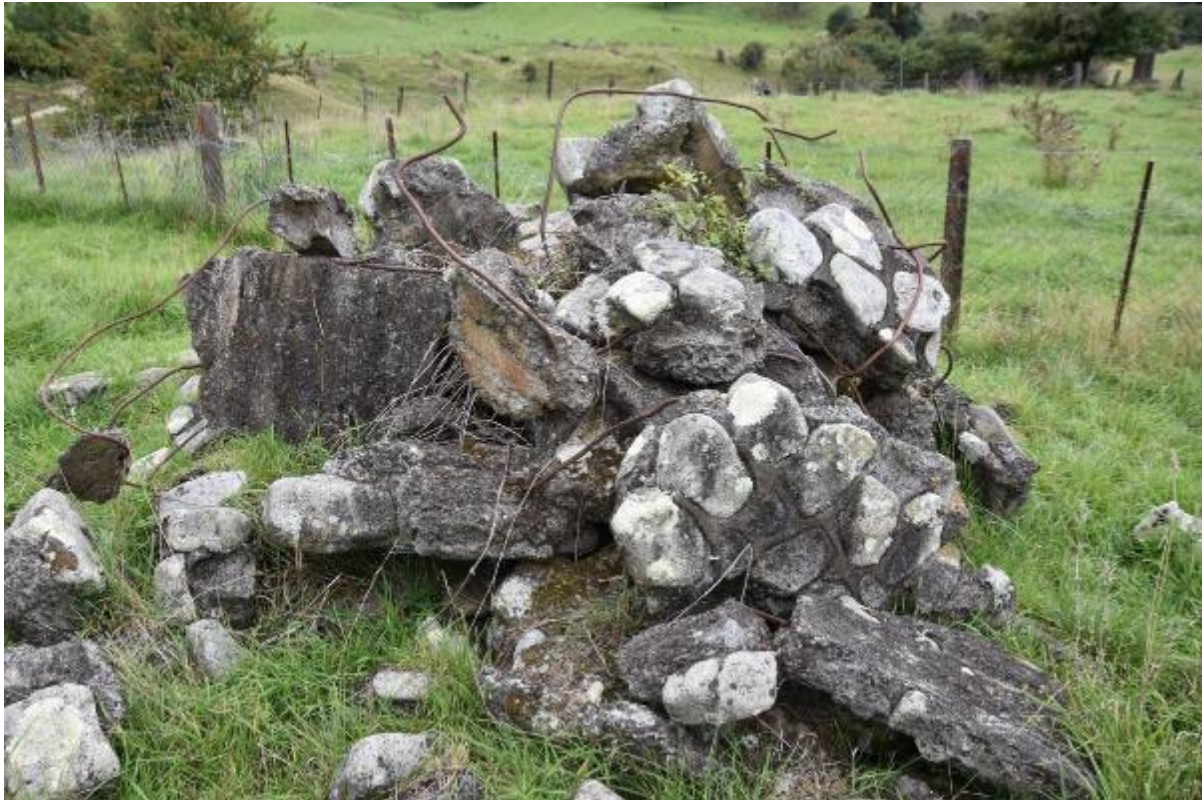
Photo 11 A pile of the concrete and stone rubble with reinforcing rods.

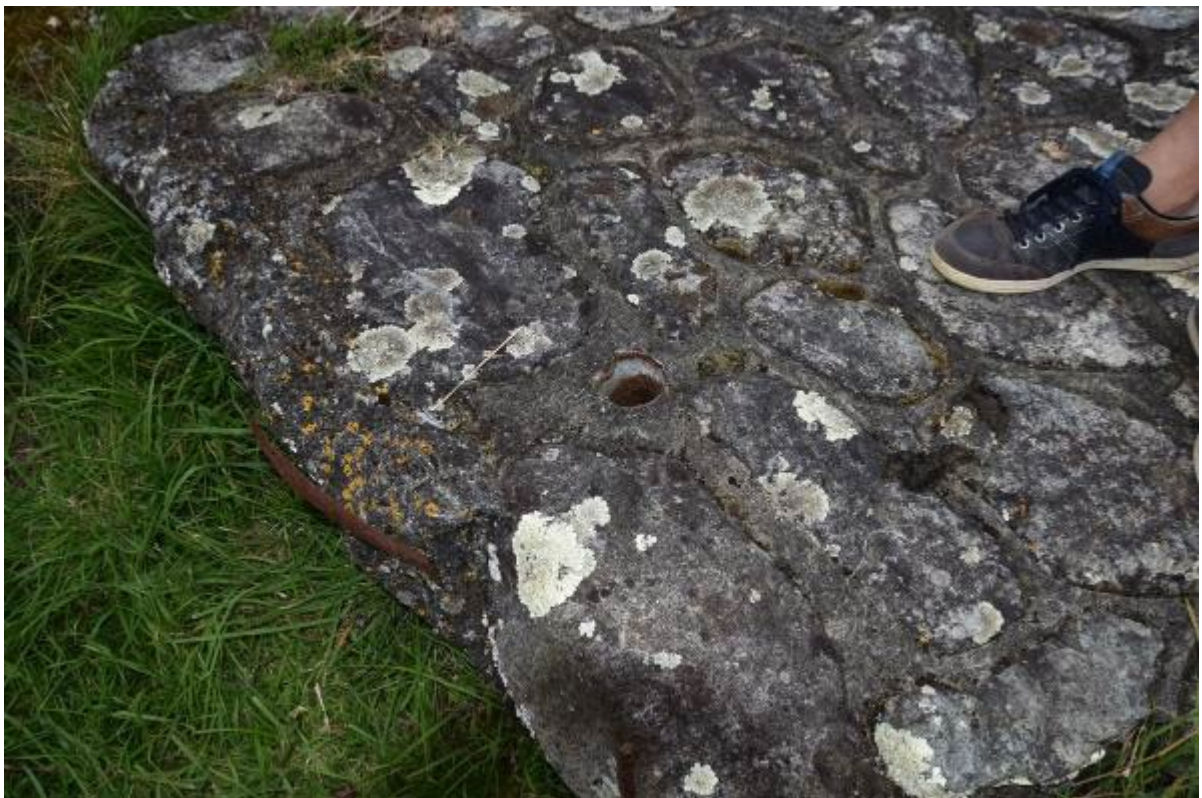
Photo 12 One of the galvanised steel (likely drainage) pipes running through the concrete.

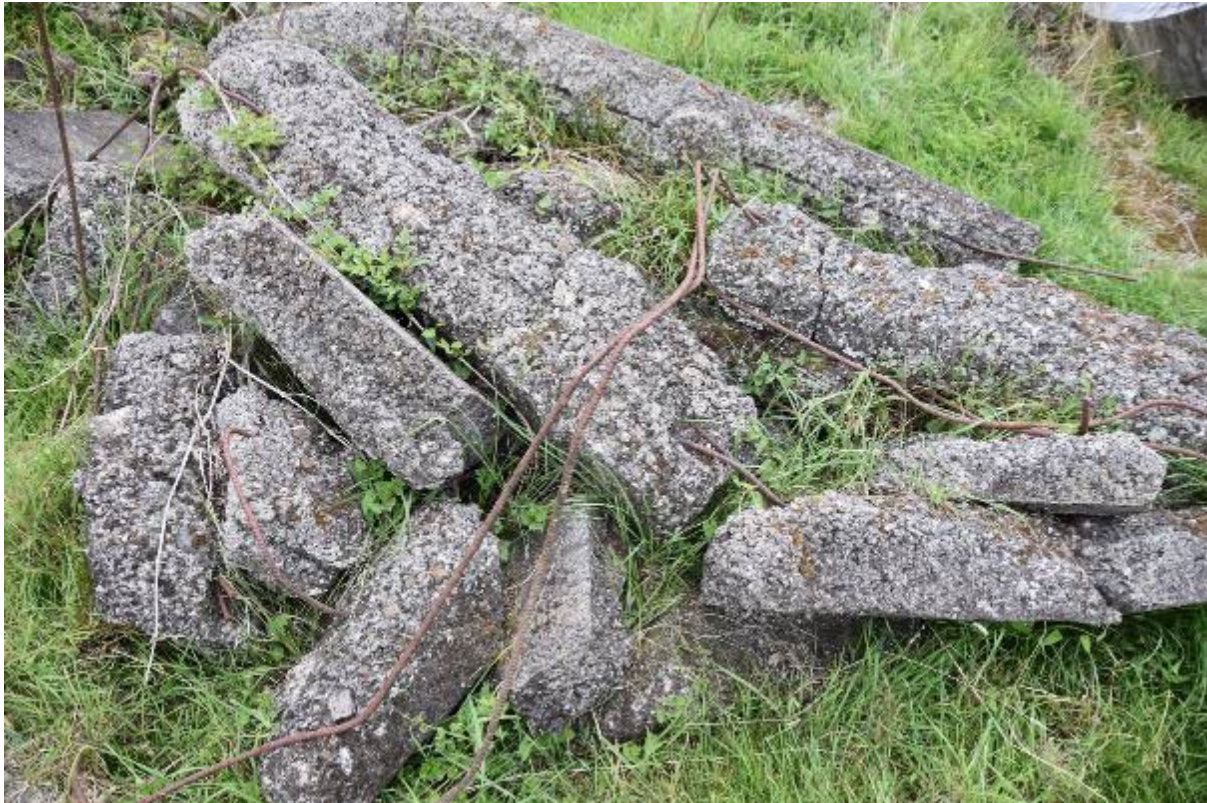
Photo 13 Plain (no stone) reinforced concrete rubble.

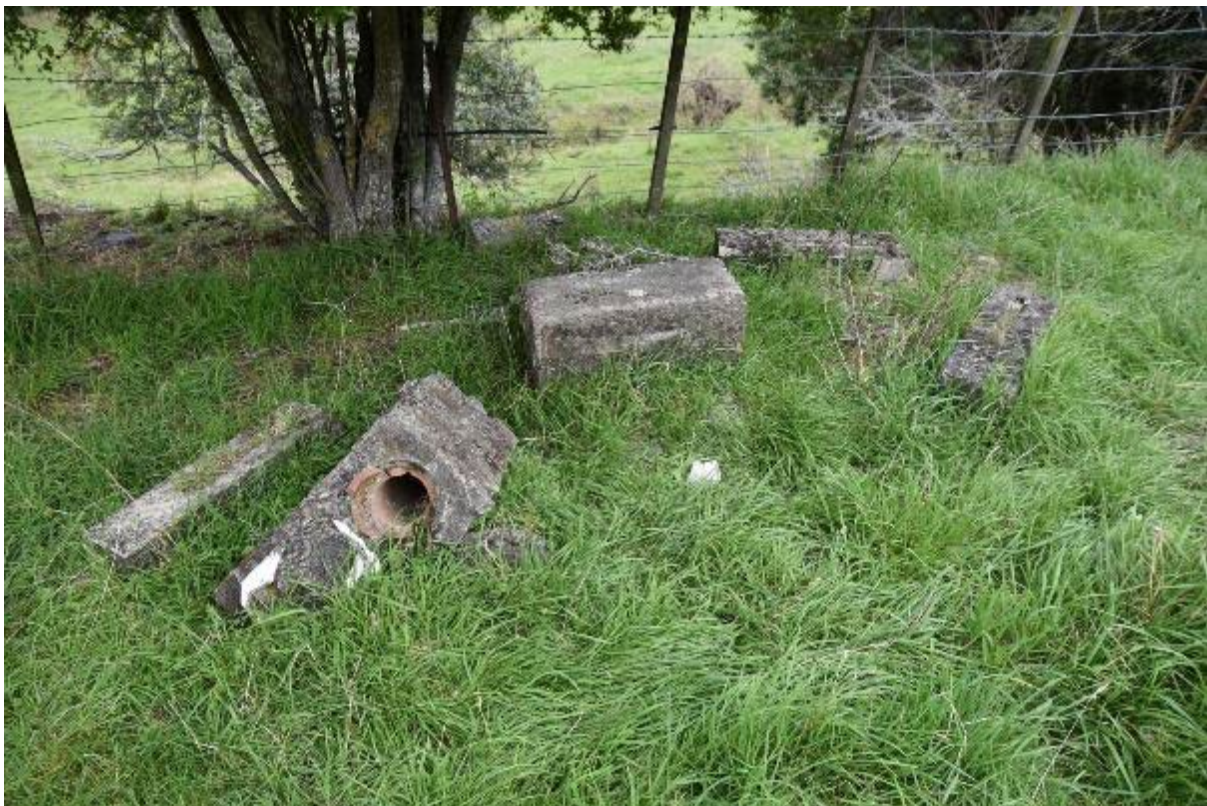
Photo 14 Concrete rubble incorporating the base of a white ceramic sanitary fitting and a sewer pipe.

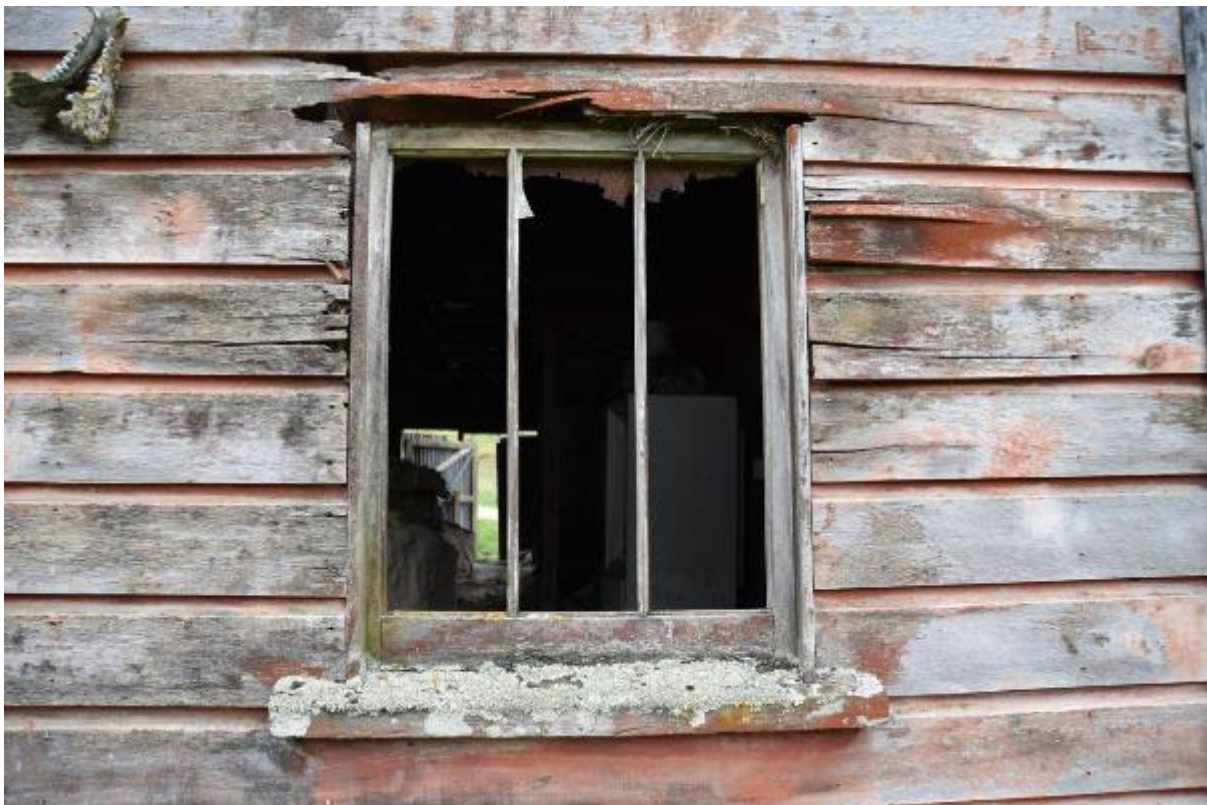
Looking at the south external elevation, the cladding is a weathered, orange-coloured rusticated weatherboard with timber piles visible along the bottom edge of the cladding. At ground floor level there are two, three-light mullion windows in timber frames with the remains of pressed pattern glass in them (22 & 23). The pattern is (or is very similar to) 'Muranese' (also sometimes known as 'Florentine'), which was first made by Chance Bros in England in the late 19th century. This is a late Victorian/Edwardian material and pattern, the use of which continued well into the early 20th century. There is a similar boarded over window in the west wall (24) and signs in the framing of a matching window in the east wall opposite.

Photo 22 One of the three-light mullion windows at ground floor level to the south elevation (with remaining piece of pressed pattern glass).

It is further recommended that the shearing equipment and the ground floor windows to Part A1 are also salvaged. Plus any timber and building materials that are recoverable and reusable.

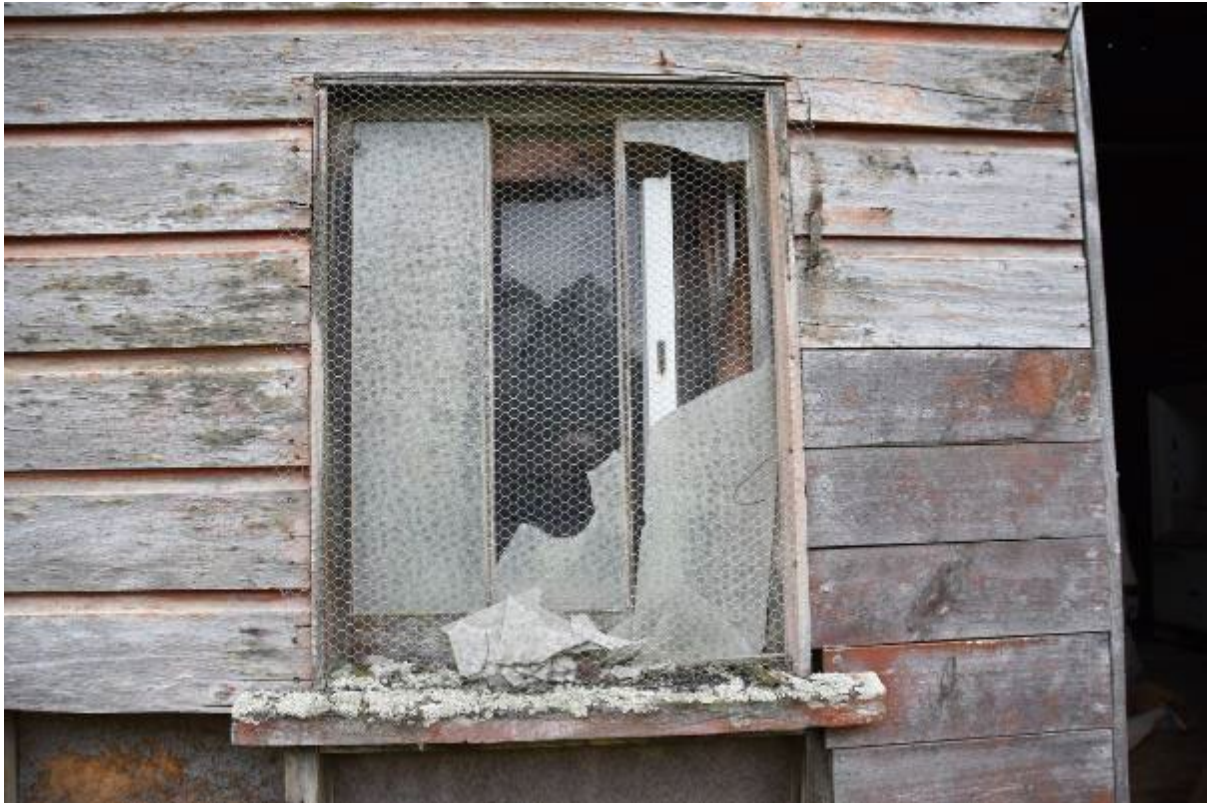
Photo 23 The other three-light ground floor south elevation window (with pressed pattern glazing).

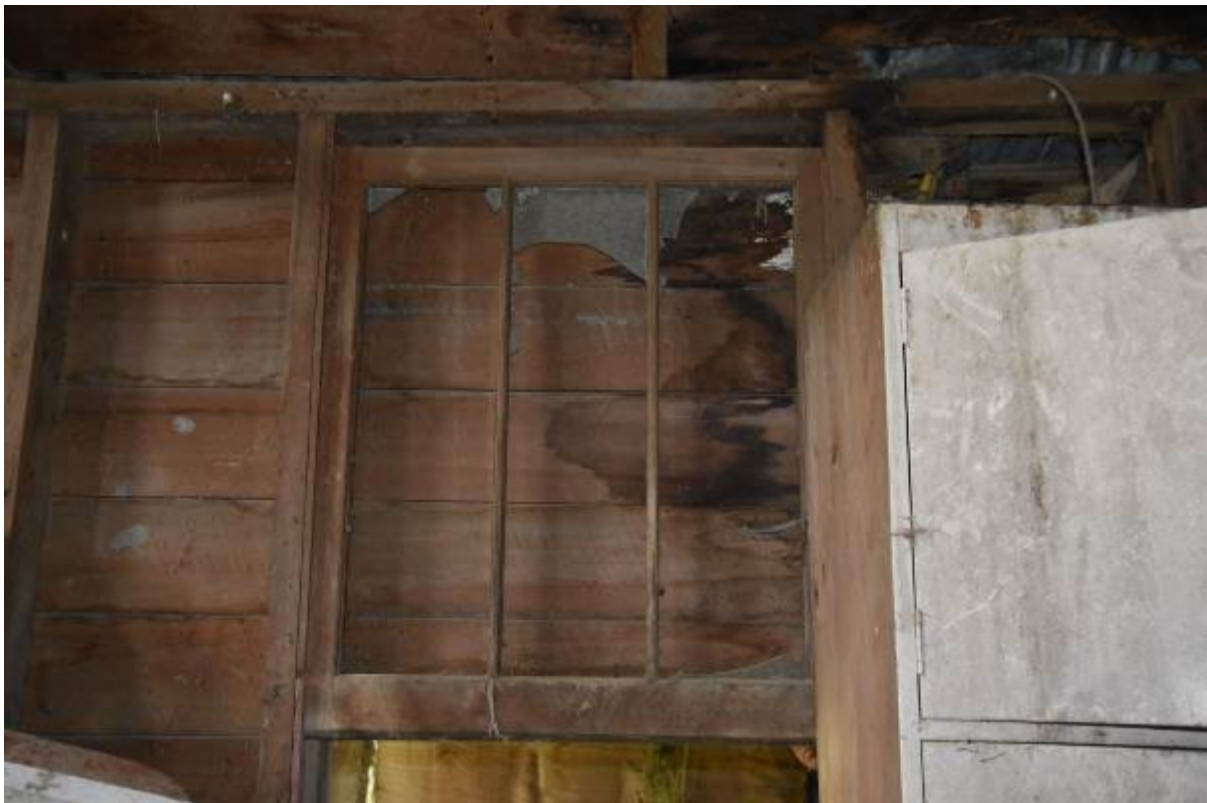
Part A1 also has (or had) many windows. In addition to the three-light ground level windows in the south wall, there is a similar window in the west wall (boarded over with rusticated weatherboards externally), and signs of a similar positioned window in the east wall (again boarded over). Glazed windows to a kiln would seem an unlikely feature, unless they were a later modification.

Photo 24 Blocked up three-light window on the west side of Part A1.

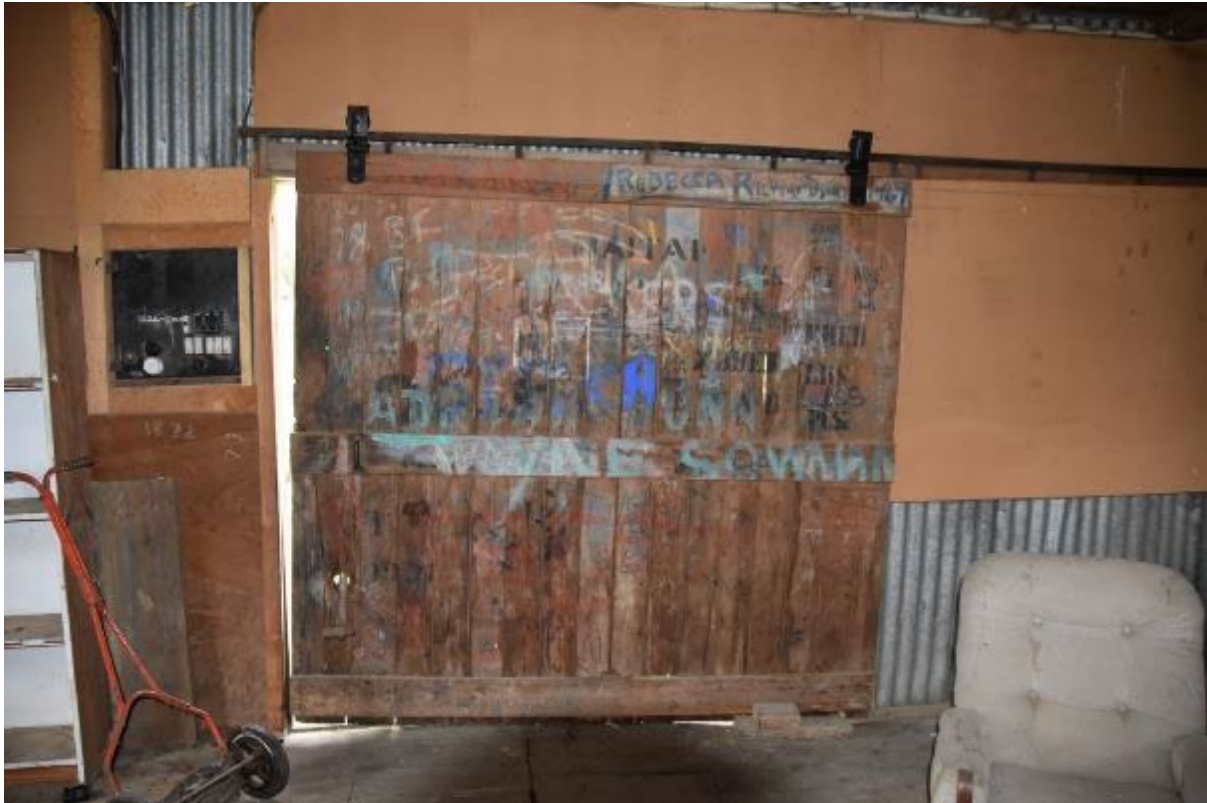
Photo 27 Shearers' graffiti on the roller door to the south elevation of Part B.

It is recommended that the shearers' graffiti on the rusticated weatherboard clad walls to Woolshed Part A1 and Part B (refer Miller 2022) is salvaged as complete timber wall panels for adaptive reuse and presentation.

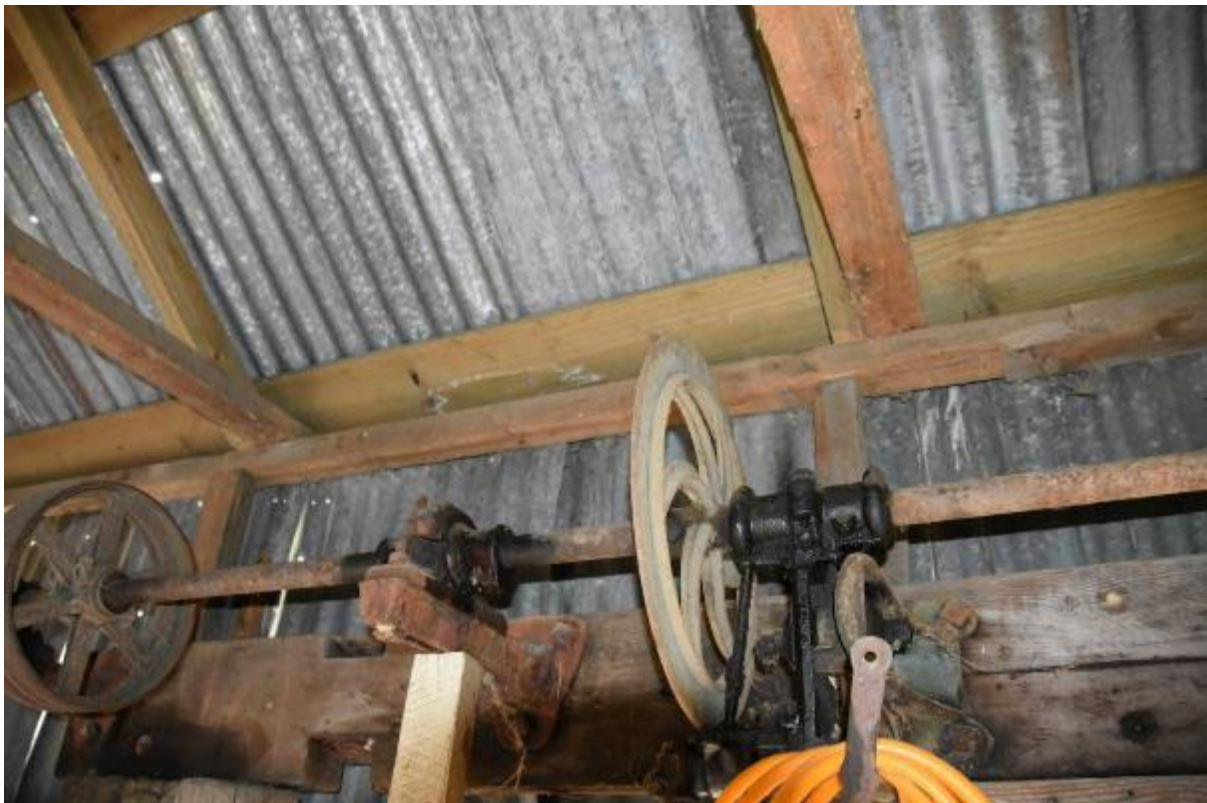
Photo 28 Shearing equipment in Part A2.
