Nelson Wastewater Treatment Plant

Resource Consent

Ecological Impact Assessment

PREPARED FOR NELSON CITY COUNCIL | MAY 2023

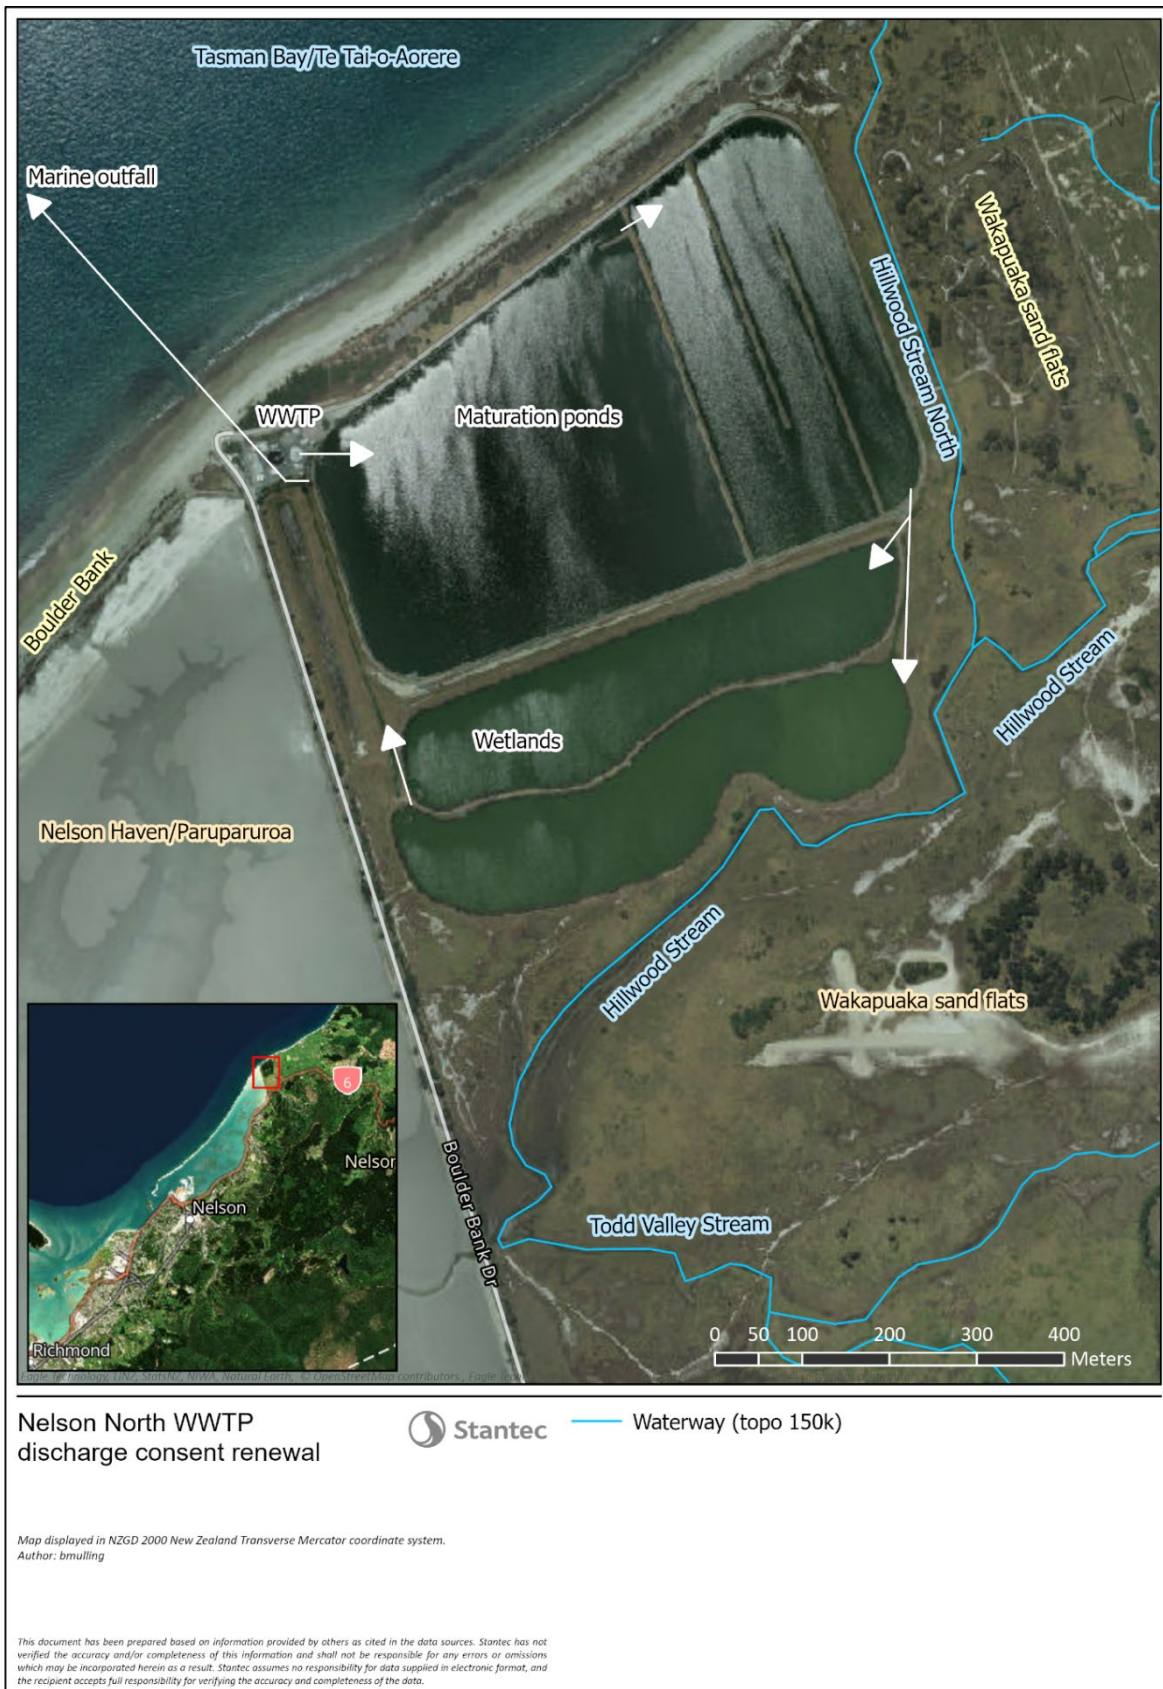
Figure 3-1: Overview of the NWWTP and surrounding environment. The overview includes labels for the main aspects of the WWTTP (white text) and indicative flow direction through the WWTTP (white arrows). A tabular representation is provided within Table 1

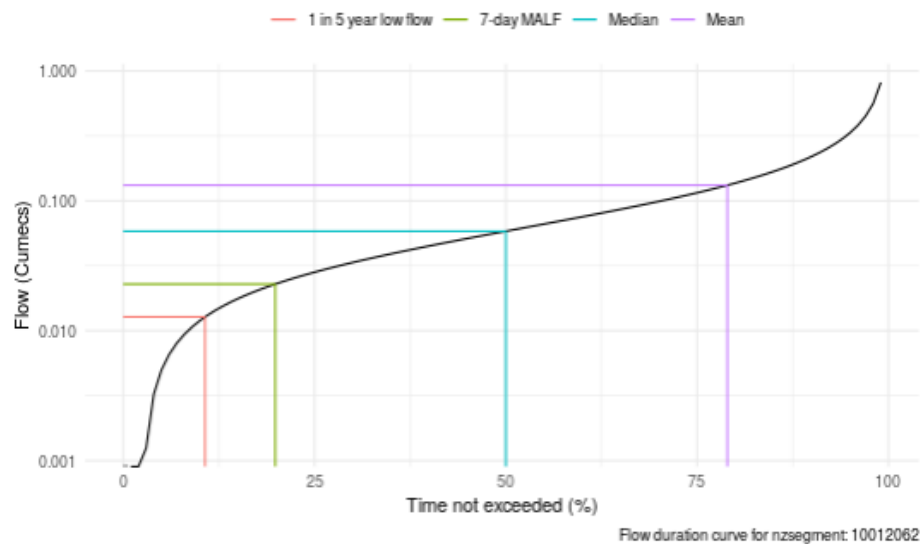
Figure 4-2: Modelled annual mean flow, annual median flow, 7-day mean annual low flow (MALF) and 1 in 5-year low flow (Booker and Woods 2014) for the lower Hillwood Stream running along the NWWTP (east to west). No data is available for the Hillwood Stream north tributary (north to south).

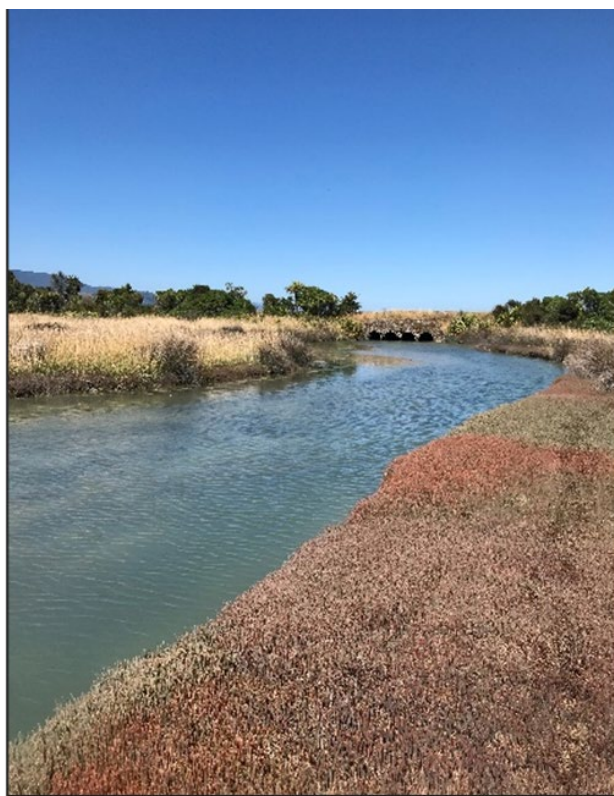
Plate 1: Hillwood Stream at location 1 (upstream view)

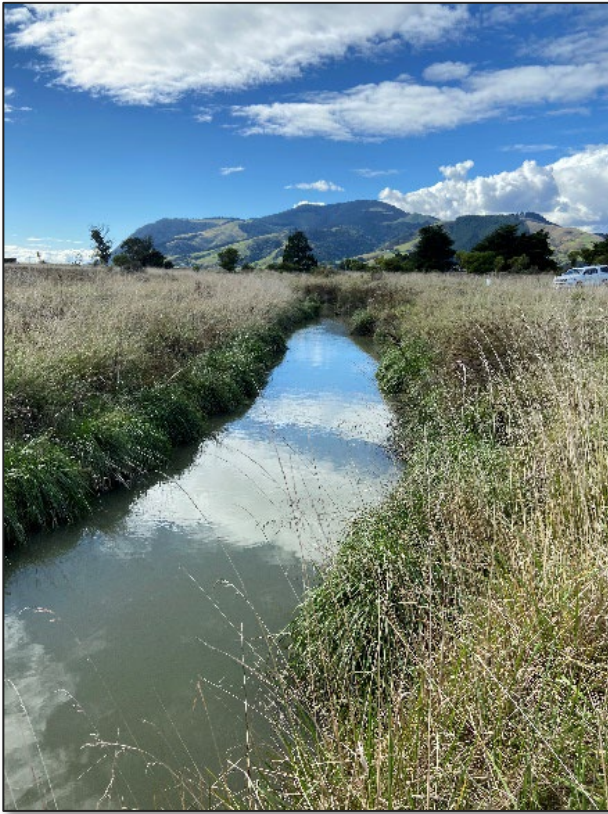
Plate 2: Hillwood Stream at location 2 (upstream view)

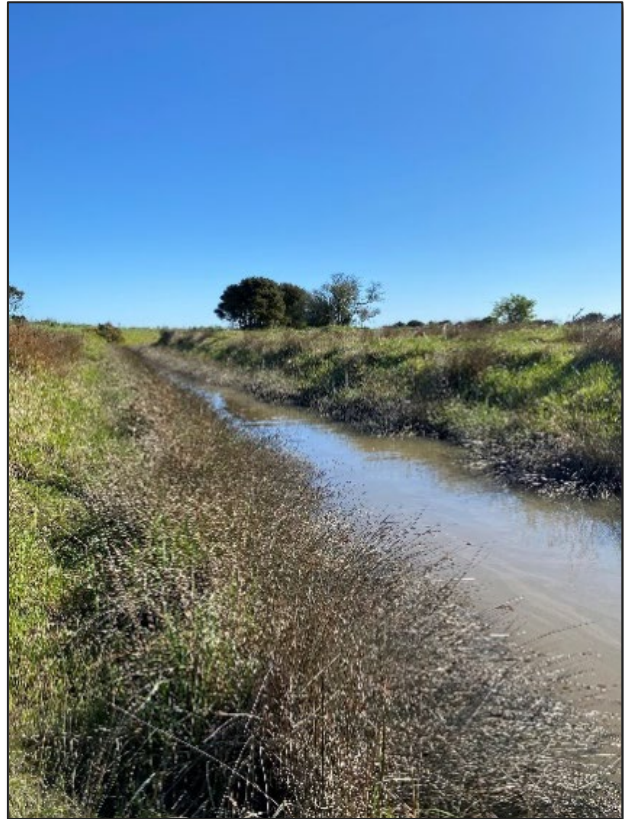
Plate 3: Hillwood Stream at location 3 (upstream view)
