IN THE MATTER of **Private Plan Change 28** to the Nelson Resource Management Plan

JOINT WITNESS STATEMENT (JWS) IN RELATION TO:

Maitahi Valley Farm Buildings, 7 Ralphine Way, Maitai Valley Nelson

Addendum Report

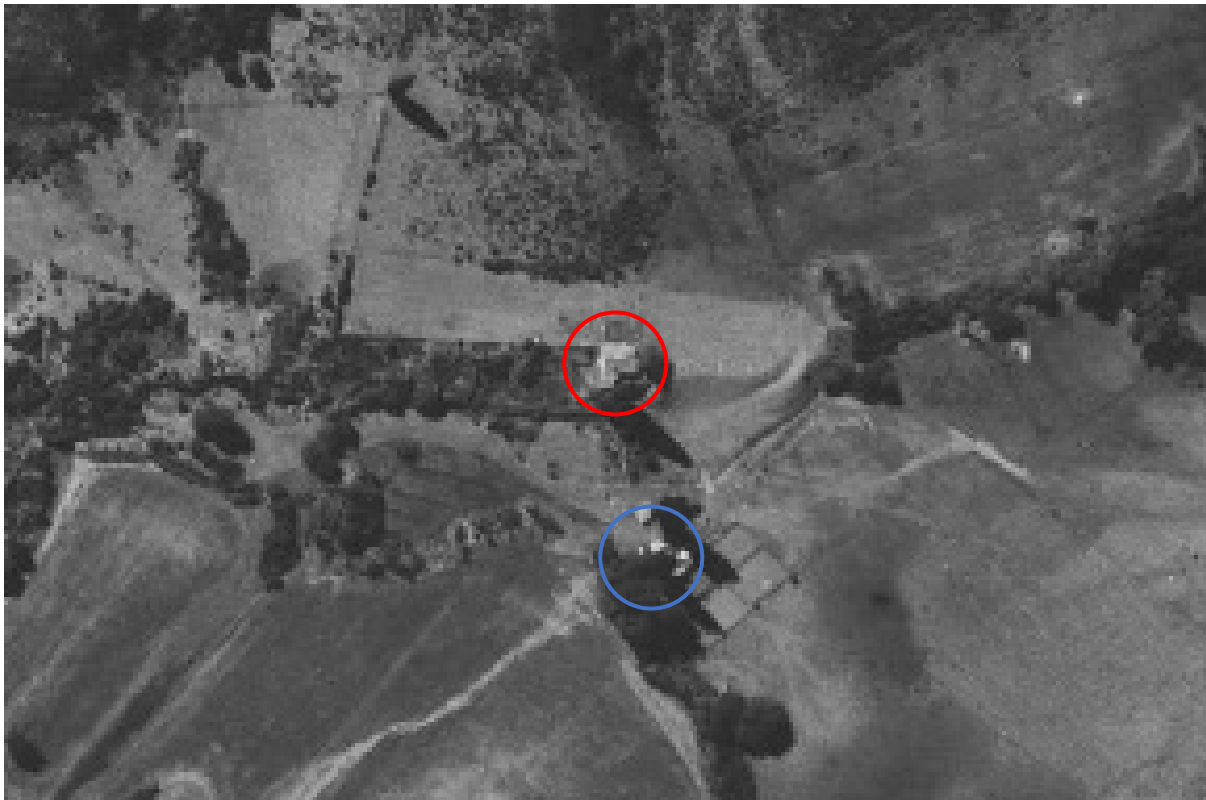
Figure 1. Retrolens, SN379, 1948.

A desk-based review of historic aerals carried out by Origin shows a building at the location of the chimney from 1948 (earliest aerial) to the 1980s (Figure 1-Figure 4).

This rubble could have come from anywhere, but if it is local to the site, a rectangular building to the west side of the homestead appeared on the site between 1948 and 1960 (see figures 1 & 2), remained present in 1983 (see figure 4), but is no longer there today. There also appears to have been some form of wall to the north of the house that is quite prominent in figures 3 & 4.

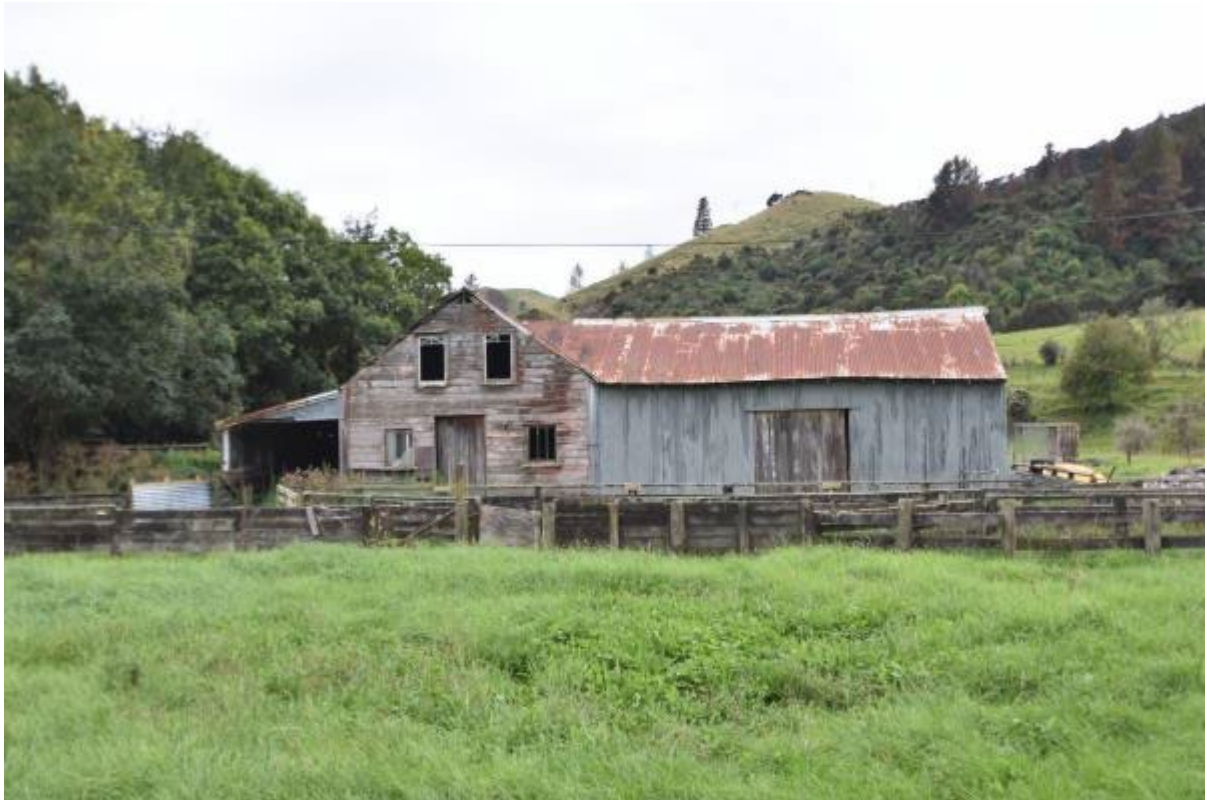
Photo 15 The south elevation with the timber weatherboard-clad gable to Building Part A. Building Part B is the corrugated iron-clad addition on the right. The lean-to on the left is Building Part C.

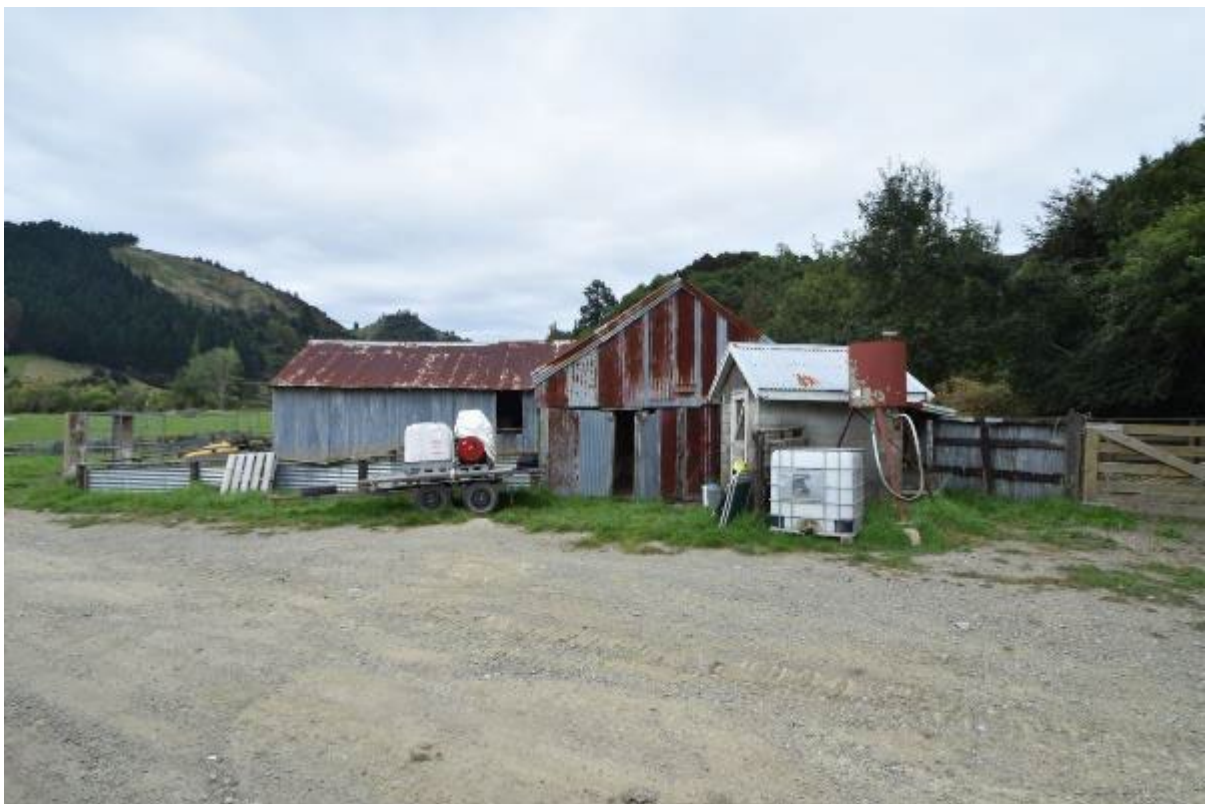
Photo 16 Looking from the north, the gable to Building Part A on the right and Building Part B on the left. Building Part C is hidden behind the small concrete block building and water tank on the right.

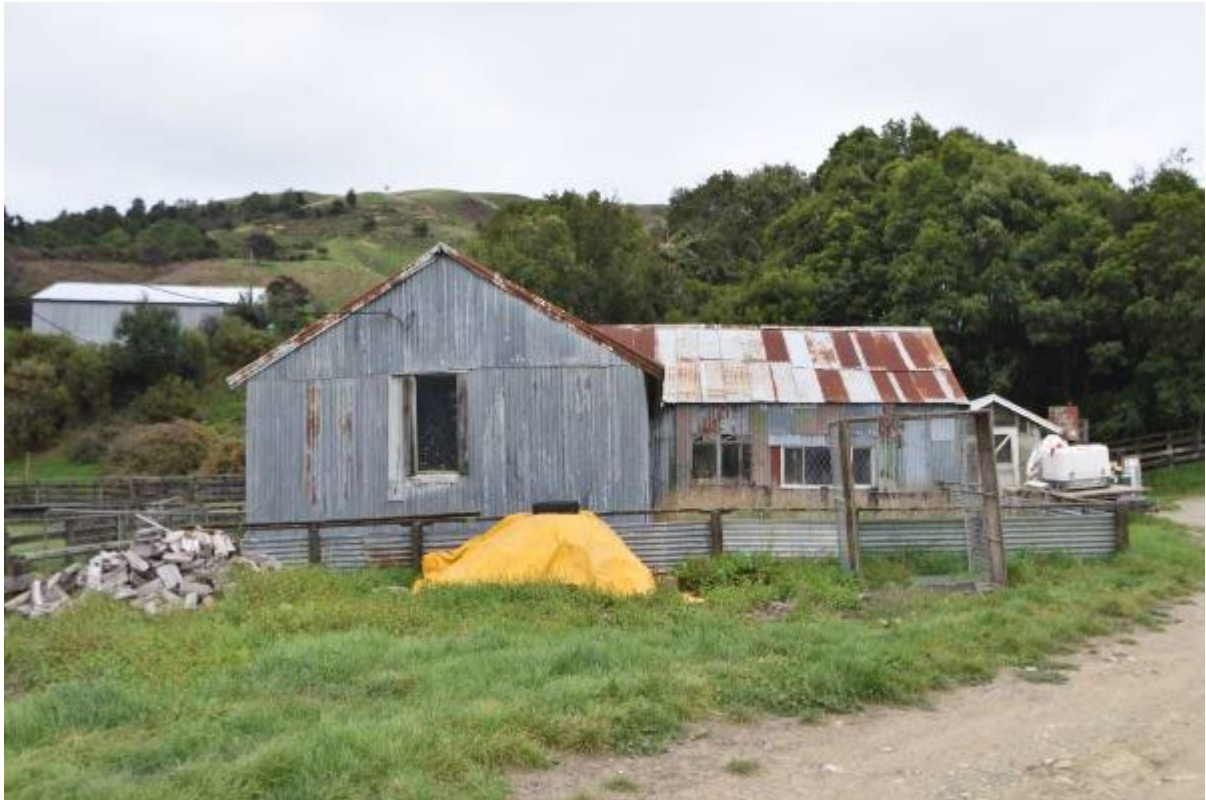
Photo 17 The east elevation with the gable to Building Part B on the left and the northern end of Building Part A on the right.

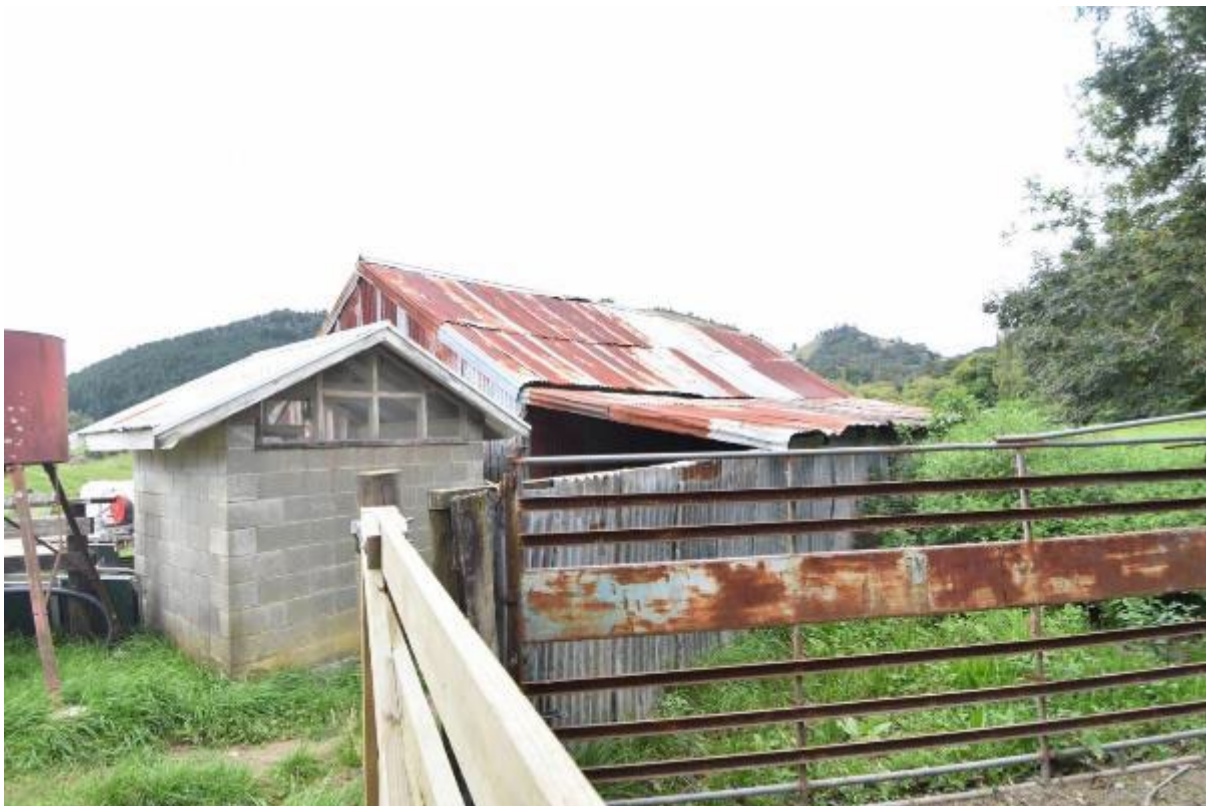
Photo 18 The lean-to (Building Part C) on the right behind the fence and gate.

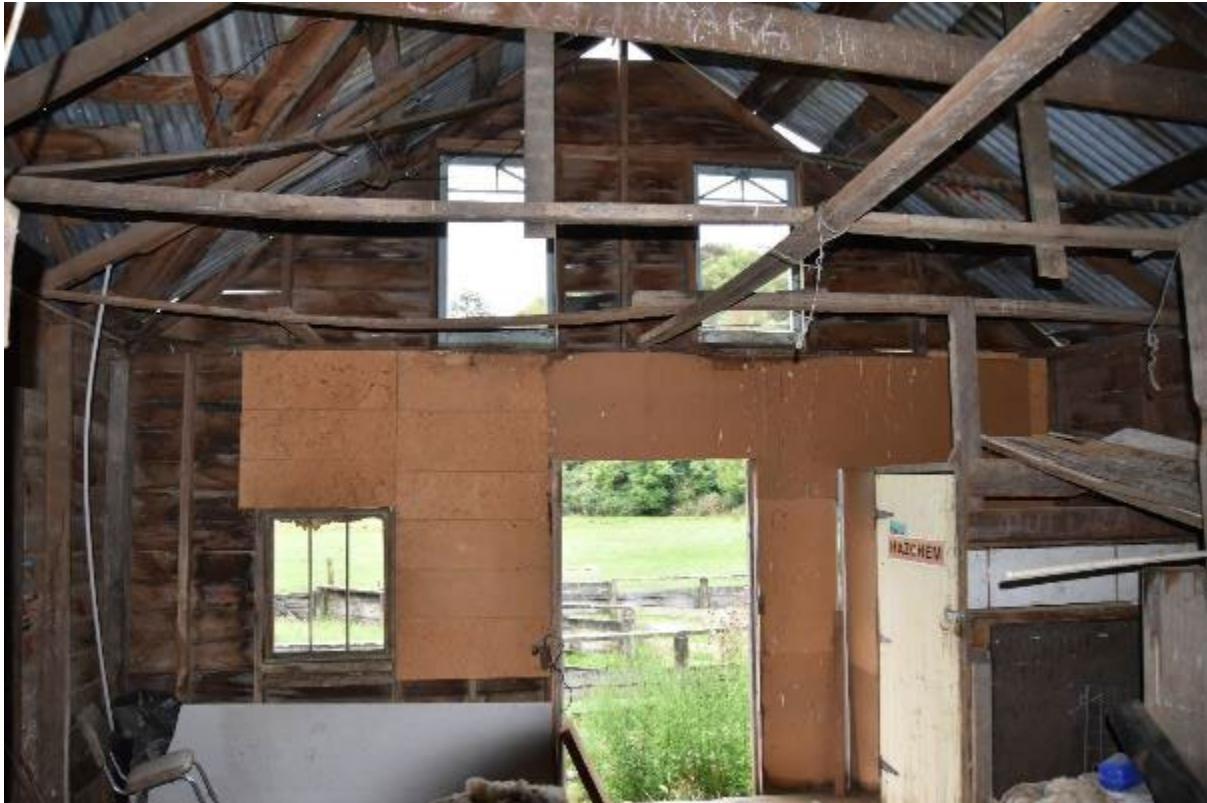
Photo 19 Interior of Part A1 looking south.

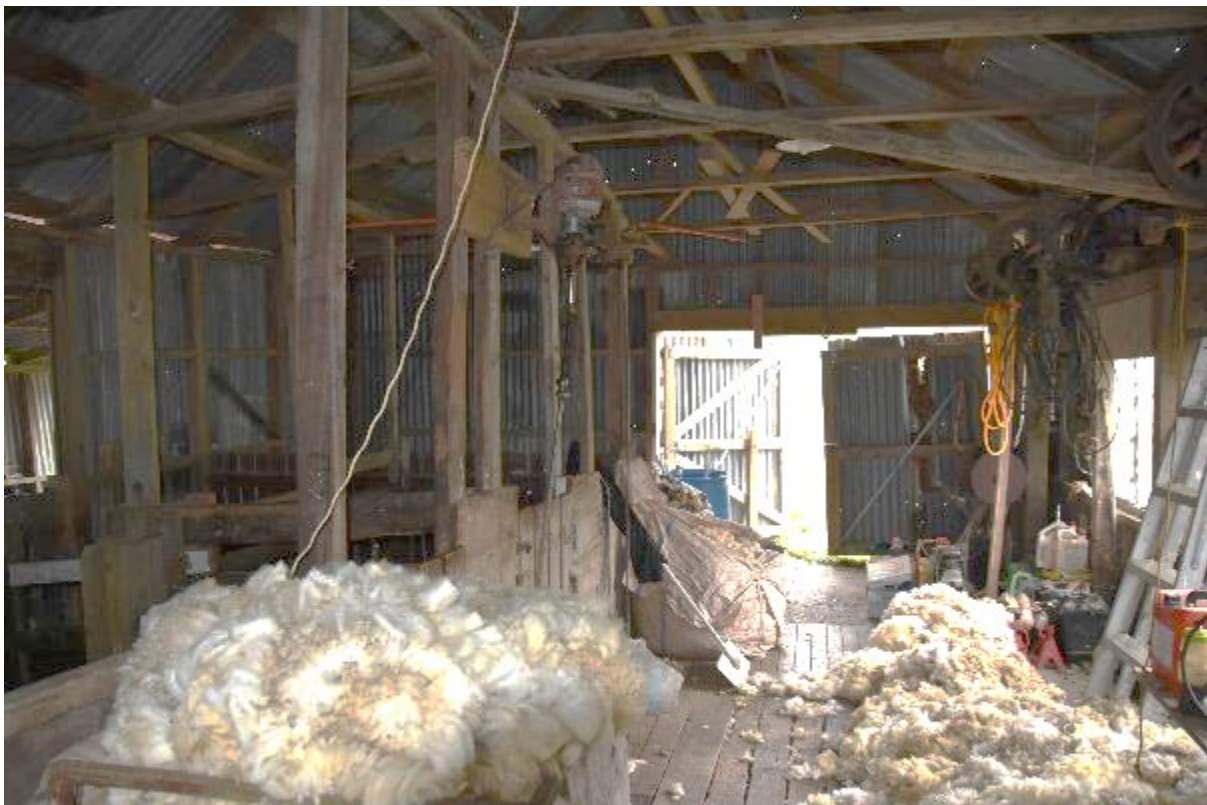
On the northeast external corner of Part A2, there are a few remains of a former rusticated timber weatherboard cladding that pre-dates the corrugated iron wall cladding.

Photo 20 Interior of Part A2 looking north.

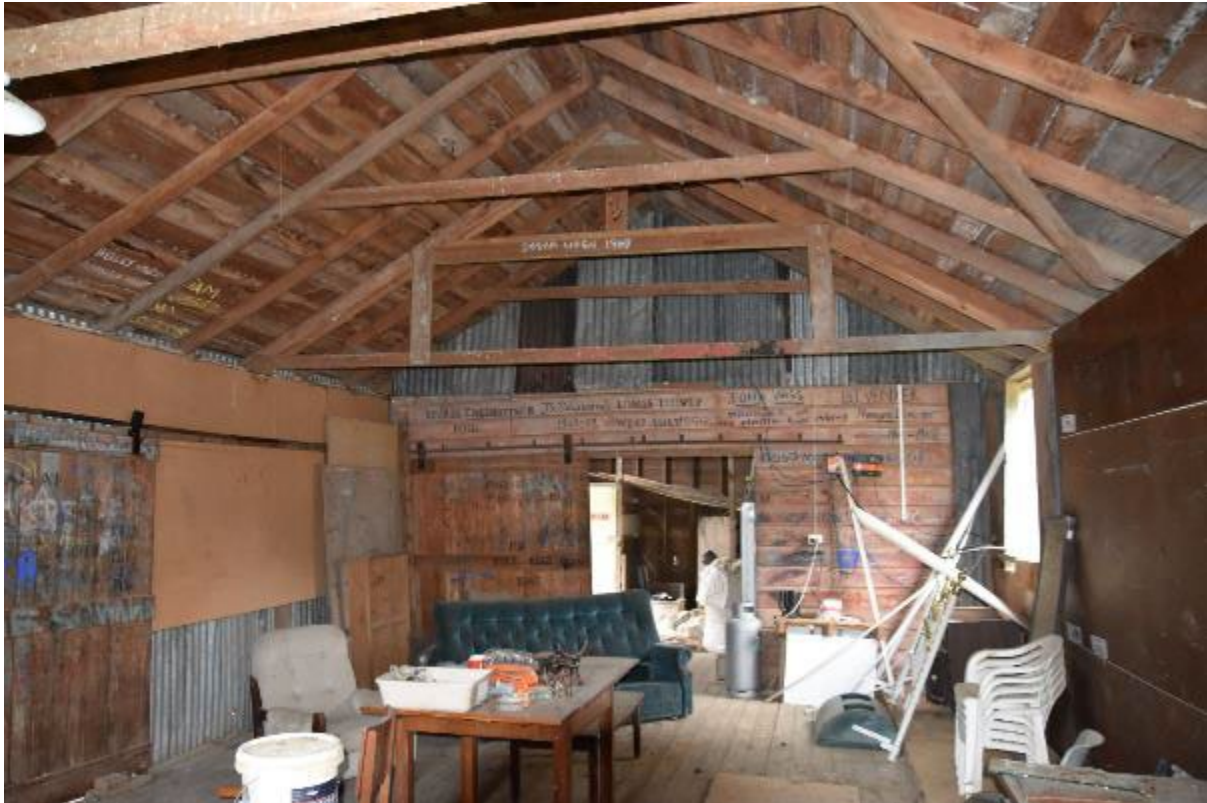
The wall studs are quite widely spaced (approximately 1200mm) and the building is clad with vertically-hung sheets of corrugated iron except for a small part of the wall which adjoins the lean-to (Part C). Here the stud spacing is similar at about 1100 - 1200mm but the external face of the studs is clad with tongue & groove sarking boards. These are not rusticated but appear to be reasonably old and indicate that the middle section of the lean-to is the oldest part of it (this is also shown in figure 2 / 1960). This is further indicated by the construction of the lean-to wall where the middle section has a double wall plate at the top of the studs and the framing at either end just has a single plate.

Photo 21 Interior of Part B looking west.
